UNITED STATES ENVIRONMENTAL PROTECTION AGENCY

MEMORANDUM

SUBJECT: Request for a Time Critical Removal Action at the San Jacinto River Waste Pits Site, Harris County, Texas

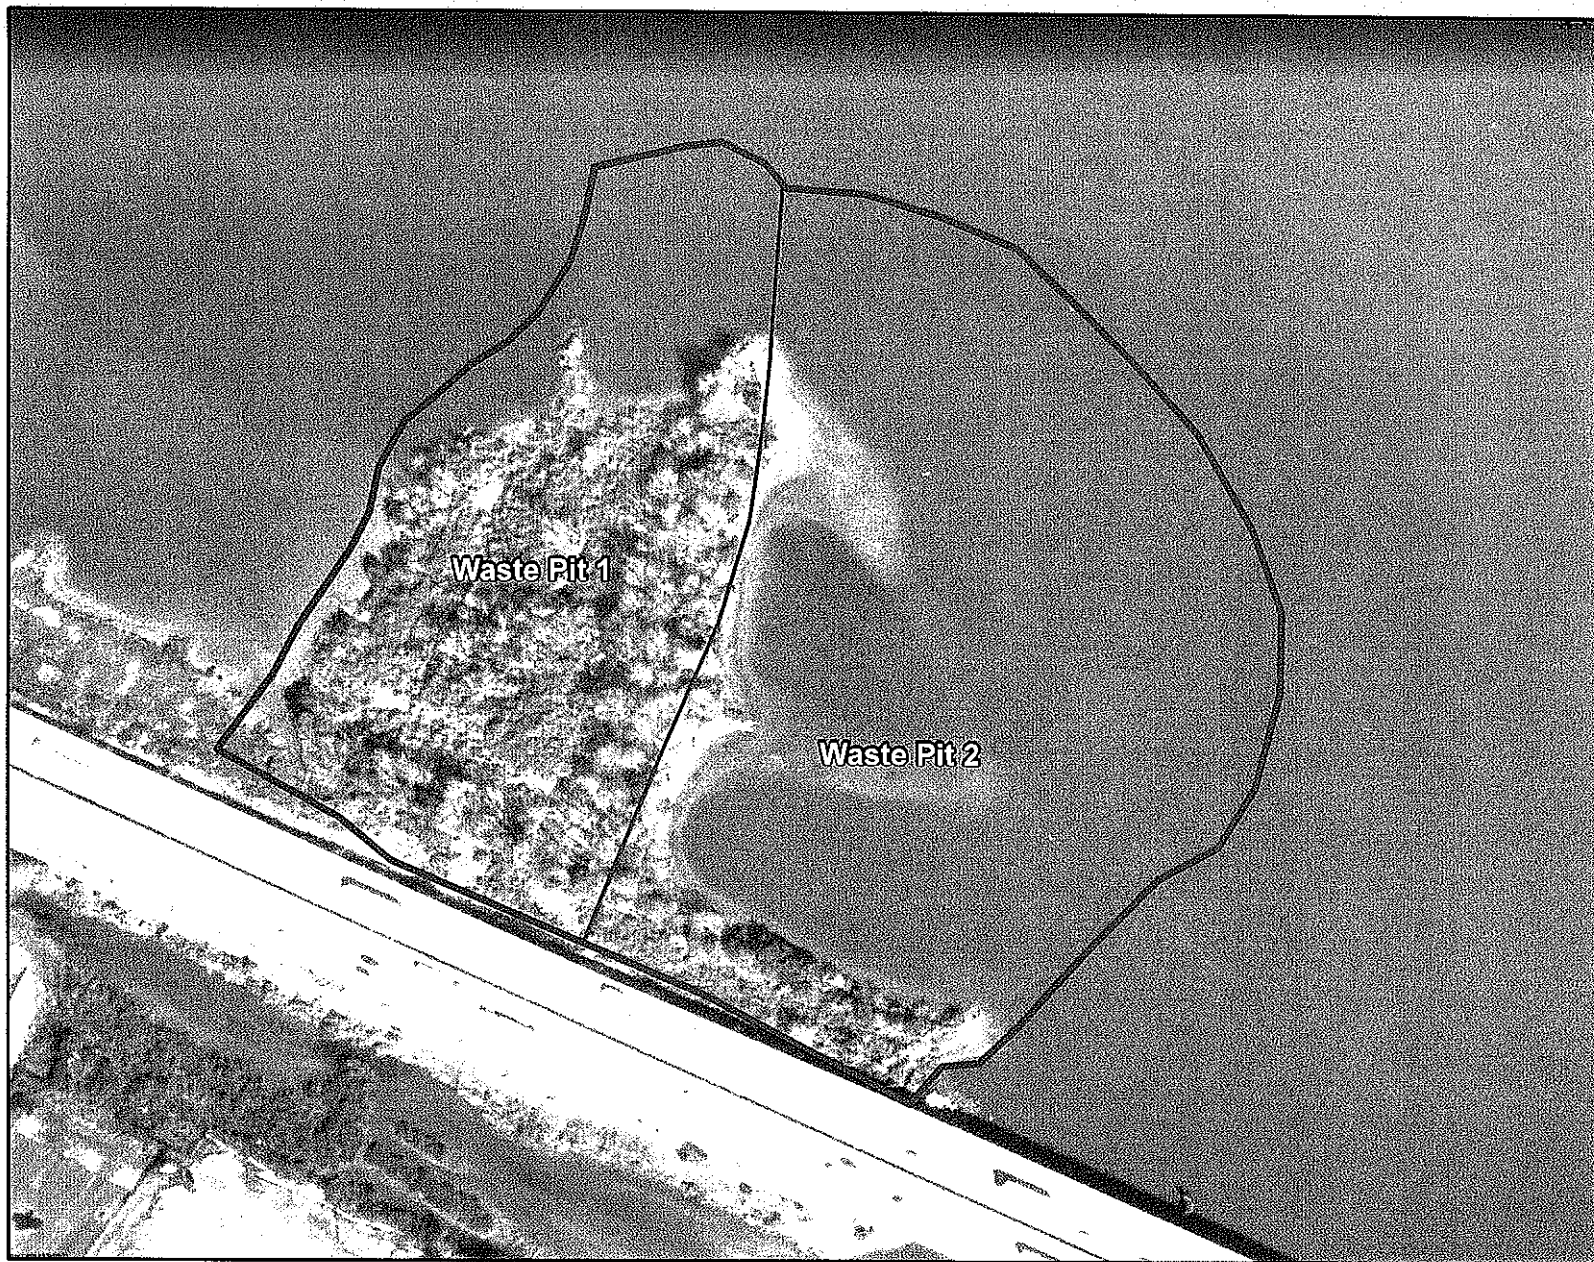
Attachment 2

The waste paper sludge was placed in the two ponds on the Tract. Waste pond 1 is located on the western portion of the Tract totaling 132,386 square feet. Waste pond 2 which consists of two surface impoundments are on the eastern portion of the Tract totaling 46,182 square feet and 188,641 square feet respectively. Currently, the Tract is inactive and approximately half of the Tract's surface area, including the abandoned waste disposal ponds, is now submerged below the adjacent San Jacinto River's water surface.

Currently, the site consists of two waste ponds (Attachment 2) containing three surface impoundments. Waste pond #1 containing one of the surface impoundments is currently being eroded by the San Jacinto River and the contents of the ponds are being released into the waterway. Sampling of waste pond #1 confirms the presence of dibenzo-p-dioxins and polychlorinated dibenzofurans with concentrations ranging from 513 ng/kg to 23,300 ng/kg (WHO 2005). Waste pond #2 which contains two of the three surface impoundments and is located on the eastern site of the property is partly submerged under water and is releasing hazardous substances into the adjacent San Jacinto River. Sediment sampling in waste pond #2 has confirmed the presence of dibenzo-p-dioxins and polychlorinated dibenzofurans with concentrations ranging from 83 ng/kg to 34,000 ng/kg (WHO 2005).

Site Map with Waste Pits 1 and 2

1966 Original Perimeter
of Impoundments

Currently, there is not sufficient data available to fully characterize the nature and extent of contamination from waste ponds 1 and 2 (Attachment 2). Additional sediment and surface water samples need to be taken immediately for the design and construction of the protective barrier. A sampling plan will be prepared and implemented immediately following the approval of this action memorandum from which environmental sampling will occur along the perimeter of the referenced 1966 dike alignment shown in Attachment 7. Any concentrations greater than or equal to 330 ng / kg of 2,3,7,8-tetrachlorodibenzo-p-dioxin (TCDD) organic carbon normalized (or 4.5 ng / kg TCDD non-organic carbon normalized) in the sediment will be considered part of the source area of contamination within the original 1966 berm placement as shown in Attachment 7 that must be addressed with the protective barrier. Any concentrations of less than 330 ng / kg of TCDD organic carbon normalized (or 4.5 ng / kg TCDD non-organic carbon normalized) found in the sediment will be addressed in future non-time critical or remedial actions at the site.

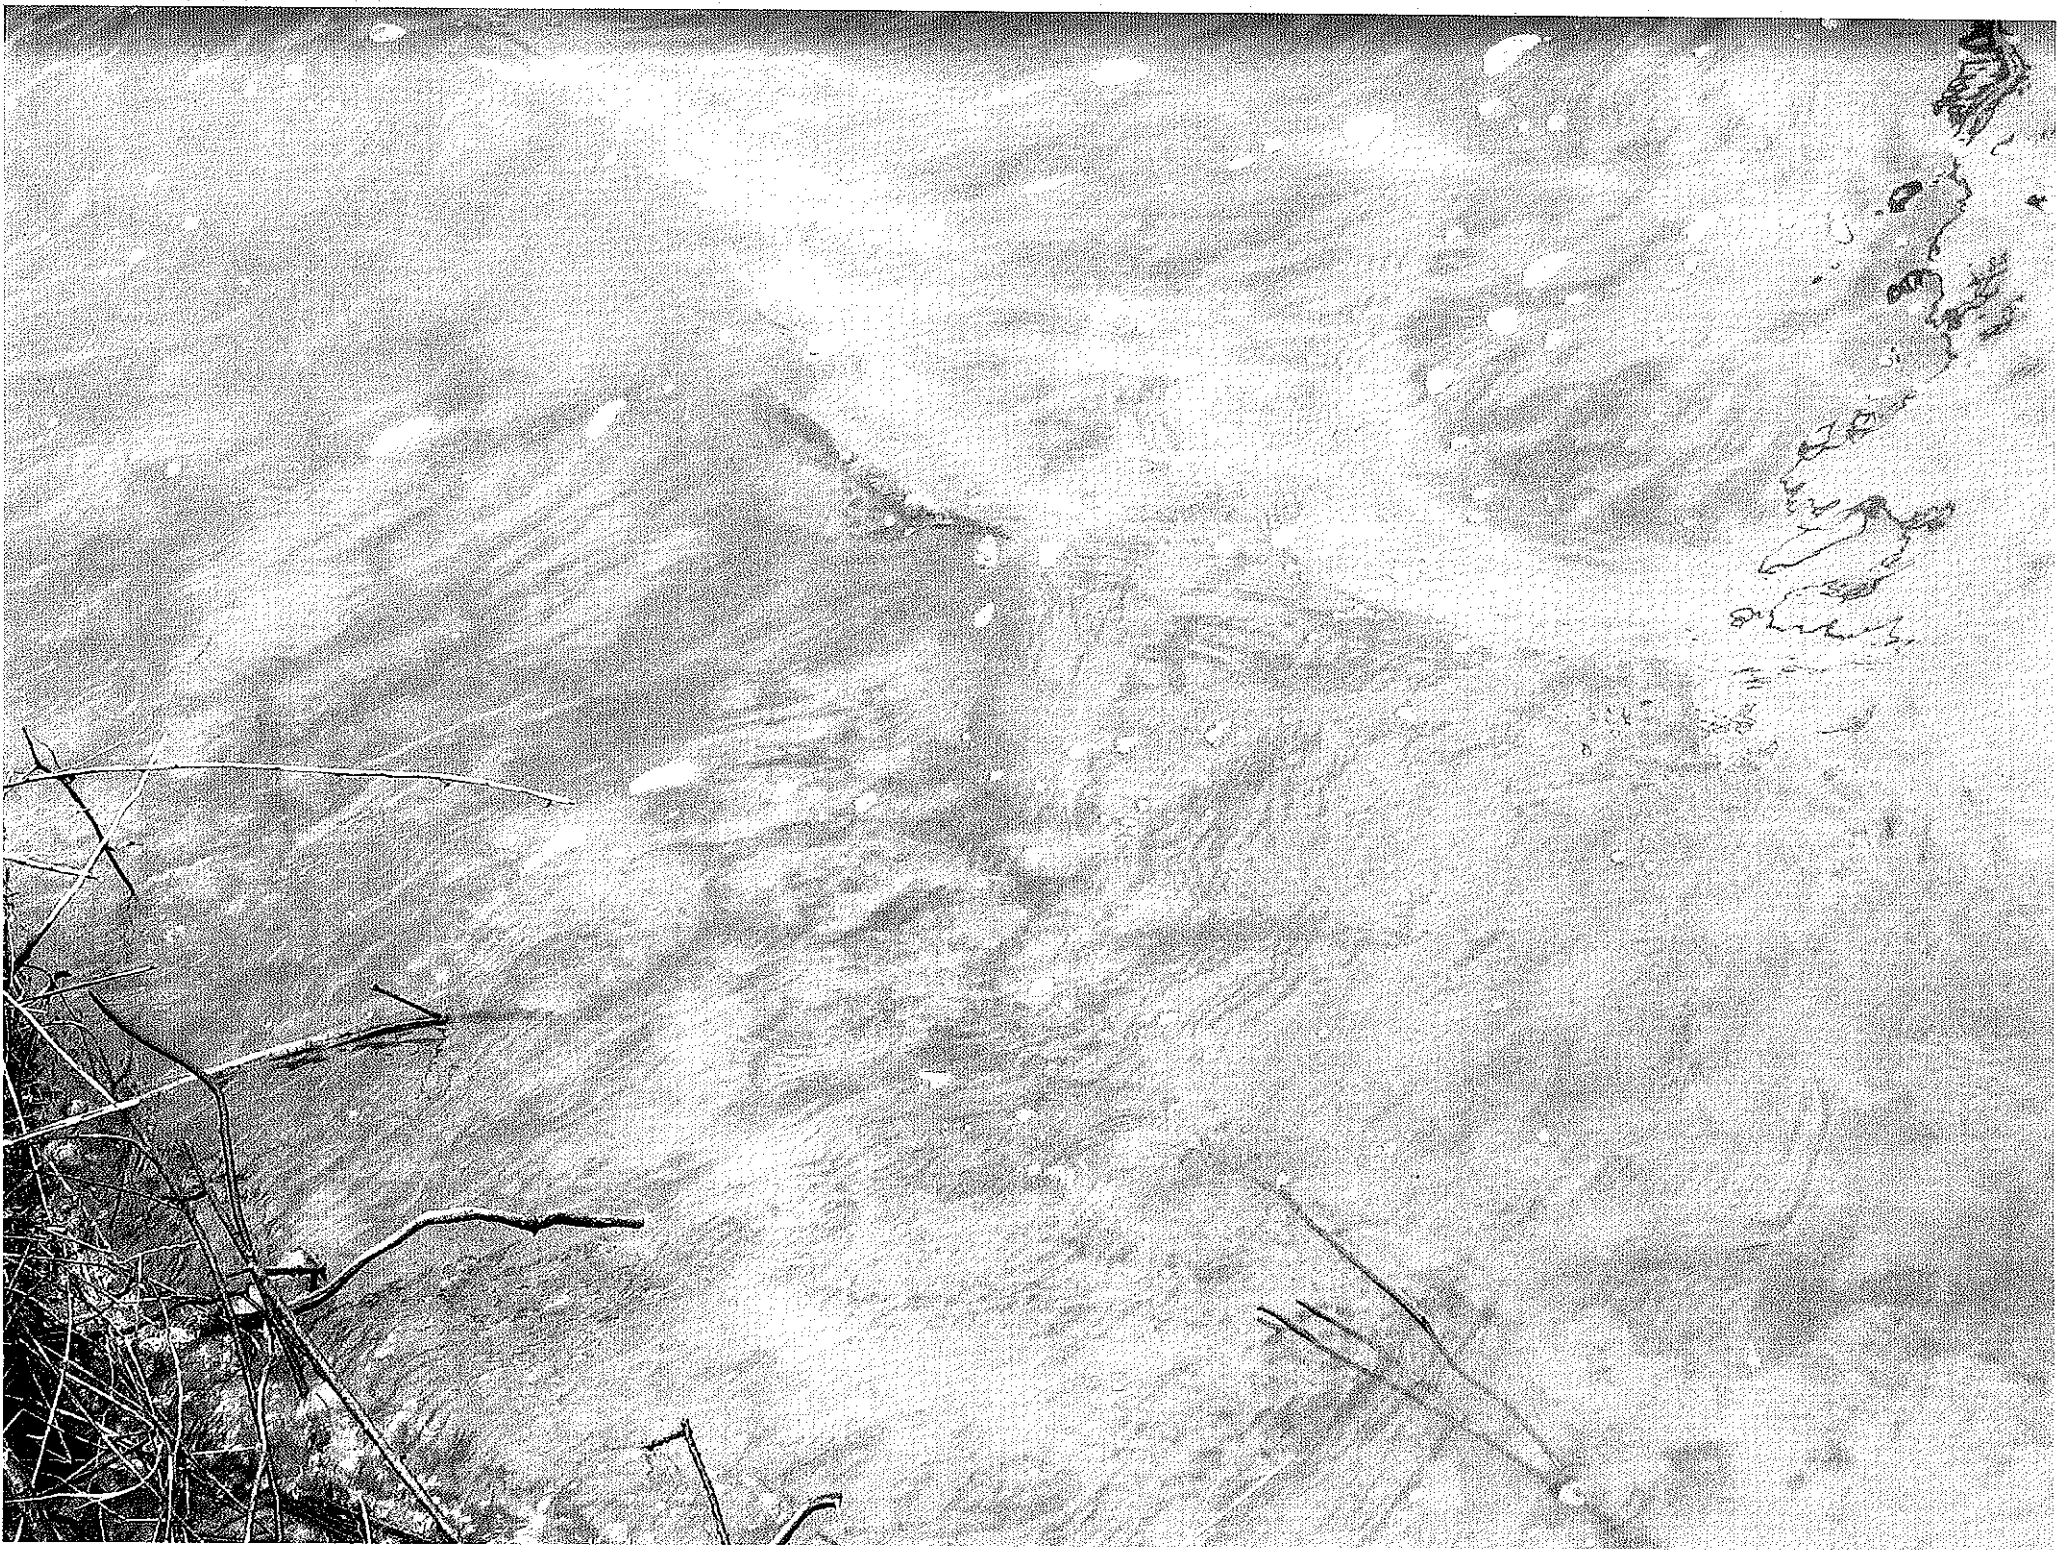
Attachment 3

A recent site visit by EPA Remedial Project Managers Leos and Tzhone on Monday March 1, 2010, documented grayish waste entering the San Jacinto River along the Northwest corner of the site from waste pond 1 (Attachment 3). In addition, 95% of Waste pond #2 was observed to be under four feet of water. Waste pond 2 consisting of two surface impoundments is continually inundated by the San Jacinto River and contaminated sediment within the source area and is in direct contact with the river water as documented in the December 1987, December 1989, February 1992, April 1998, June 1999, May 2002, February 2003, and April 2005 aerial photographs of the Tract (Attachment 6).

Site photos of waste entering San Jacinto River dated 03/01/2010

The proposed action for this time critical removal involves the immediate design and construction of a physical protective barrier surrounding waste ponds 1 and 2 that address the release or threat of release of dibenzo-p-dioxins and polychlorinated dibenzofurans into the San Jacinto River. In addition to a physical protective barrier to keep the waste secure, there is currently unrestricted public access at the site. Public access restrictions must be put in place immediately following the approval of this action memorandum. The public access restrictions should involve placement of security fences and signs to prevent trespassing onto the property. The security fencing will prevent access of unauthorized persons into the entire area containing the waste impoundments.

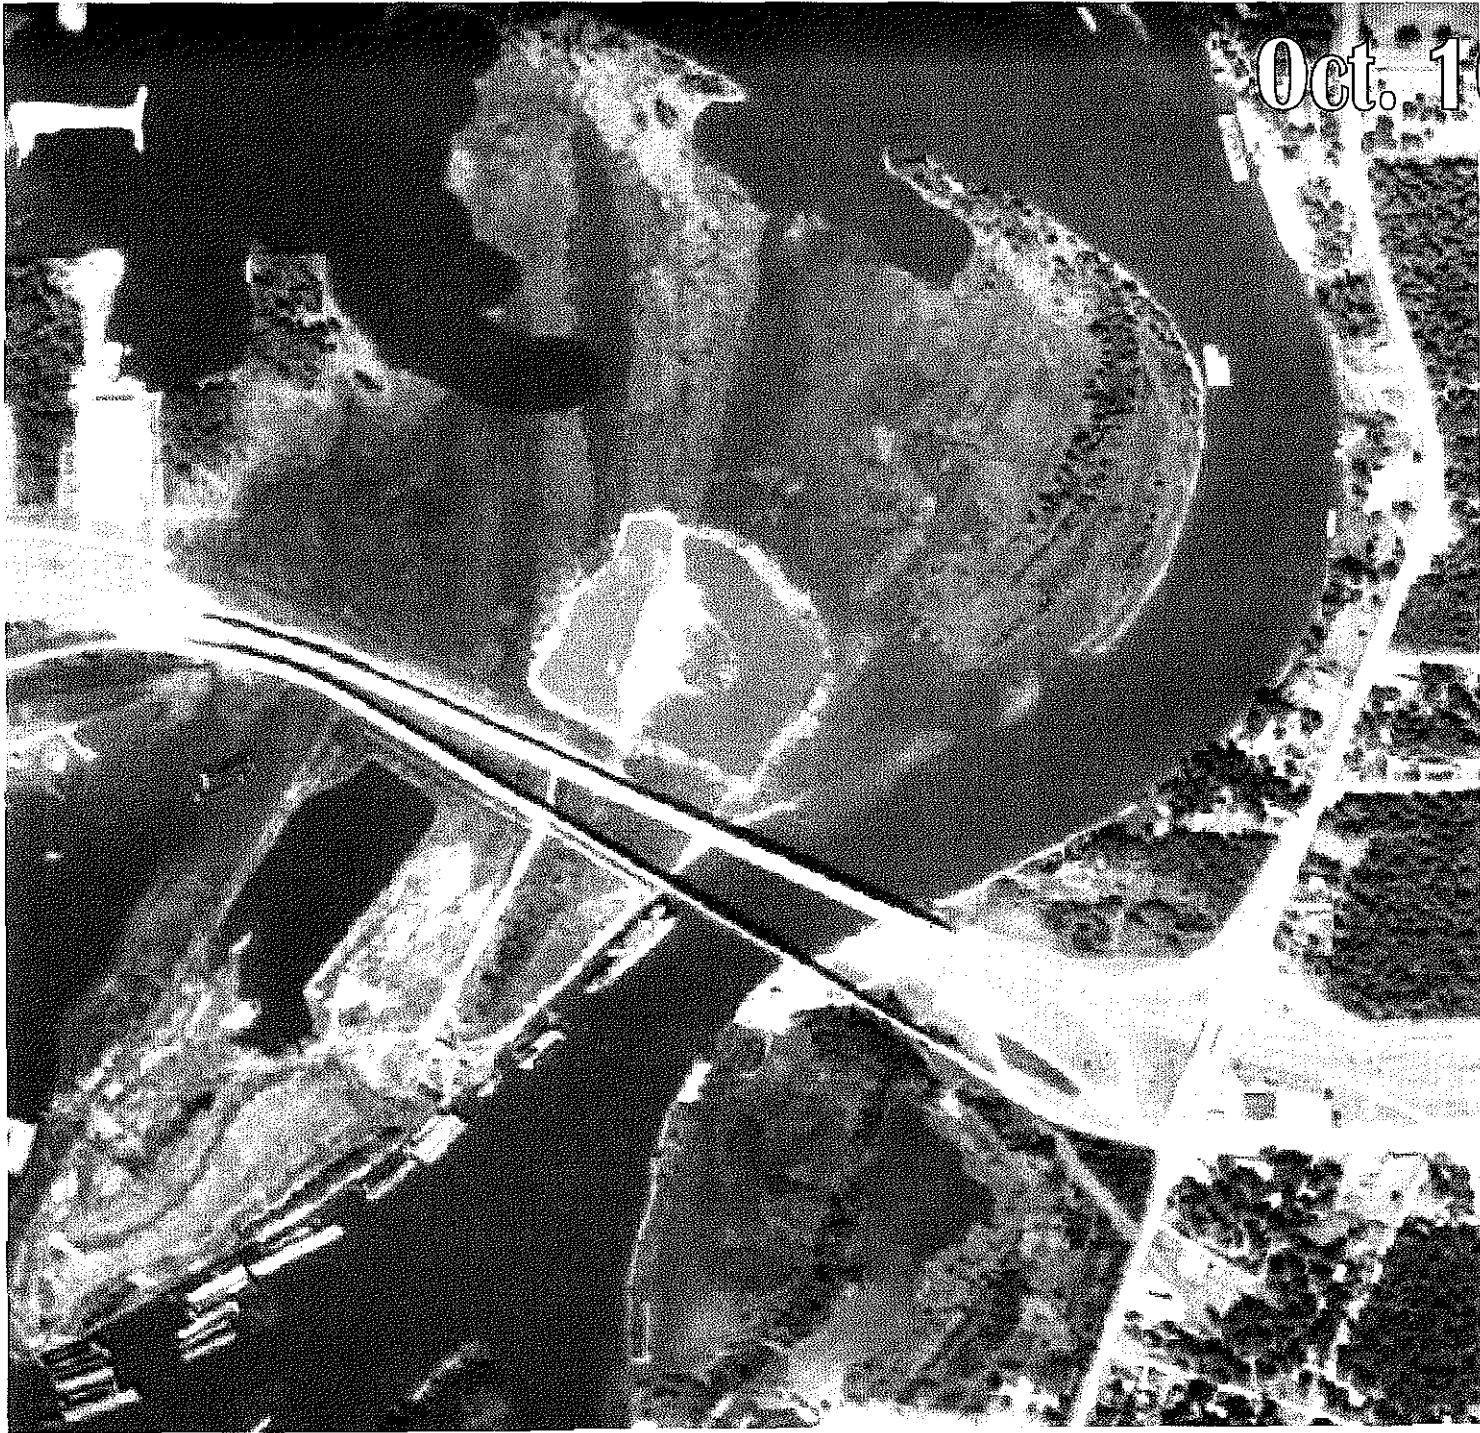
Oct. 16, 1966

Historical Aerial photos of site
